ASSURED HOME INSPECTION

1313 MOCKINGBIRD LANE

Report Prepared For:
FRED AND WILMA CLIENT

Report Prepared By:
KEVIN BARRE

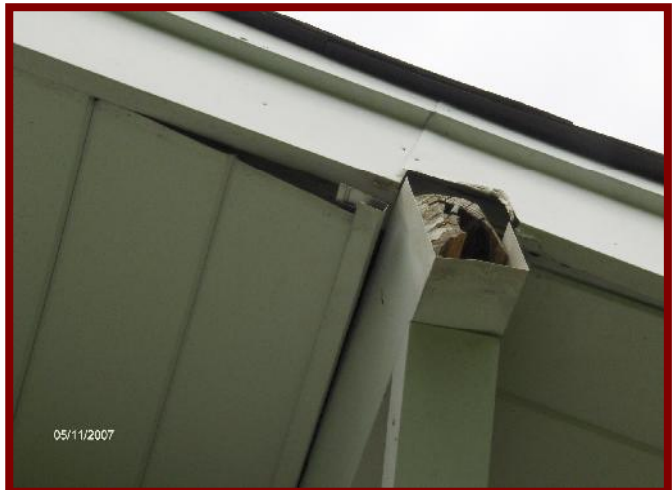
(2) There is loose and/or missing aluminum cladding on some trim sections. If water gets between the cladding and the original wood it is intended to protect, the water can become trapped and cause accelerated rot damage. Repairs are advised. Note also the loose soffitt cladding.

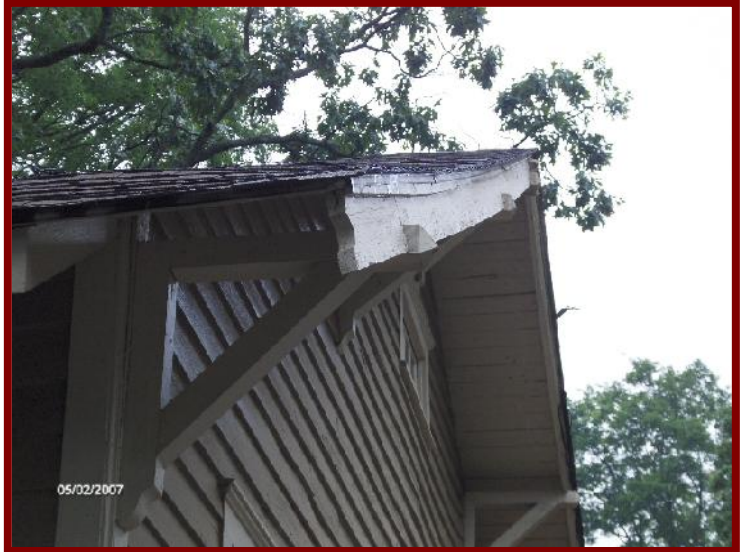
(3) The barge rafters on the gable ends sag. In my opinion, this is typical given the age and design of the home, and I doubt that this condition will worsen noticeably as long as the wood is not allowed to deteriorate due to lack of maintenance. I would advise monitoring this for any signs of future movement and making repairs then if needed.

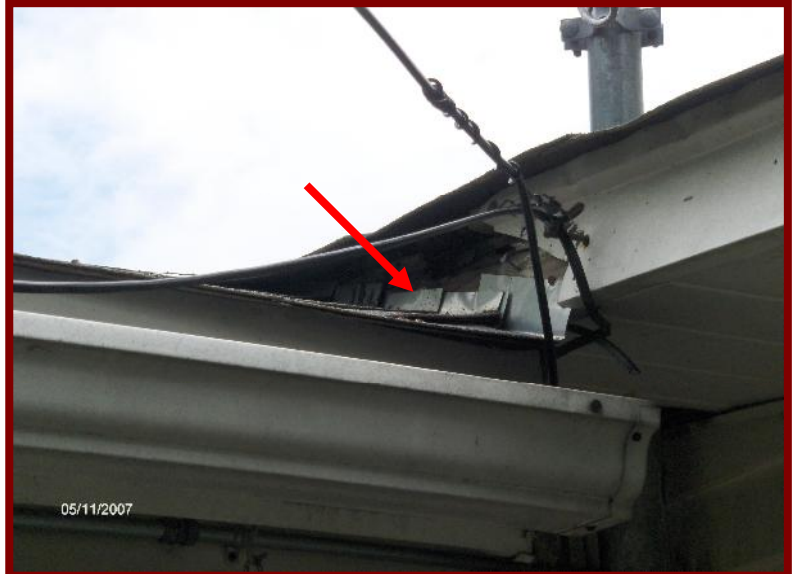
(4) There are areas of minor soffitt and/ or fascia damage or missing fascia which need repair to prevent further water damage. A competent handyman or carpenter can make repairs.

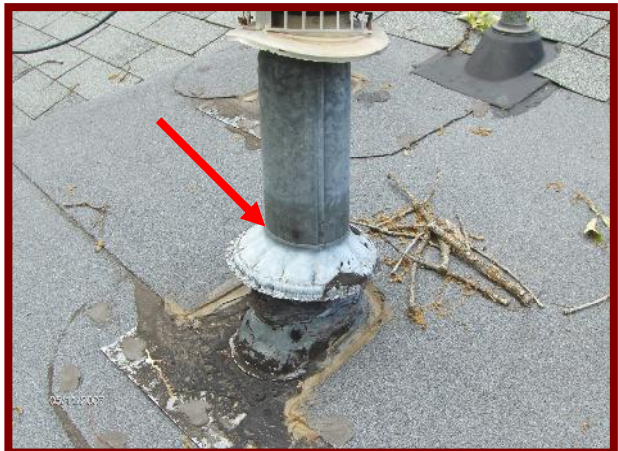
(3) The storm collar for the water heater exhaust vent needs caulking to stop water seepage down the flue. This water seeping in can cause premature corrosion damage to the water heater.

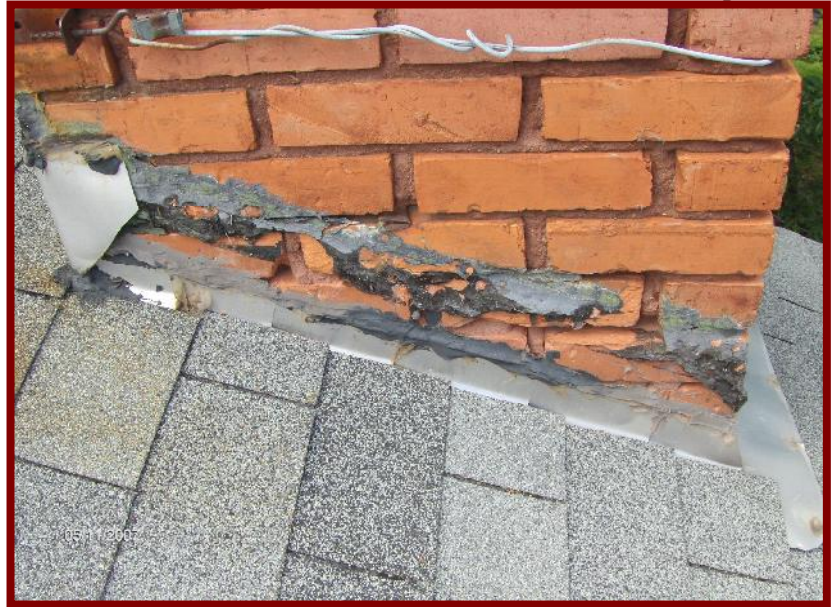
(4) There is missing flashing at the base of the chimney. There should be base and counter flashing added as was there originally. If not done, this will lead to leaks and greater than normal maintenance needs as the tar currently relied on to avoid leaks dries out and cracks.

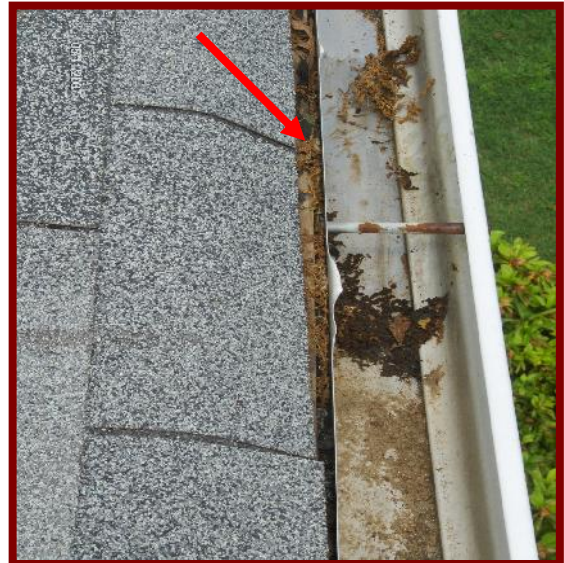
(7) There is a section of fascia cover on the front which has come loose and is allowing water to drain on the back side of the aluminum fascia cover. This traps water and must be repaired to avoid further rot damage to the wooden fascia.

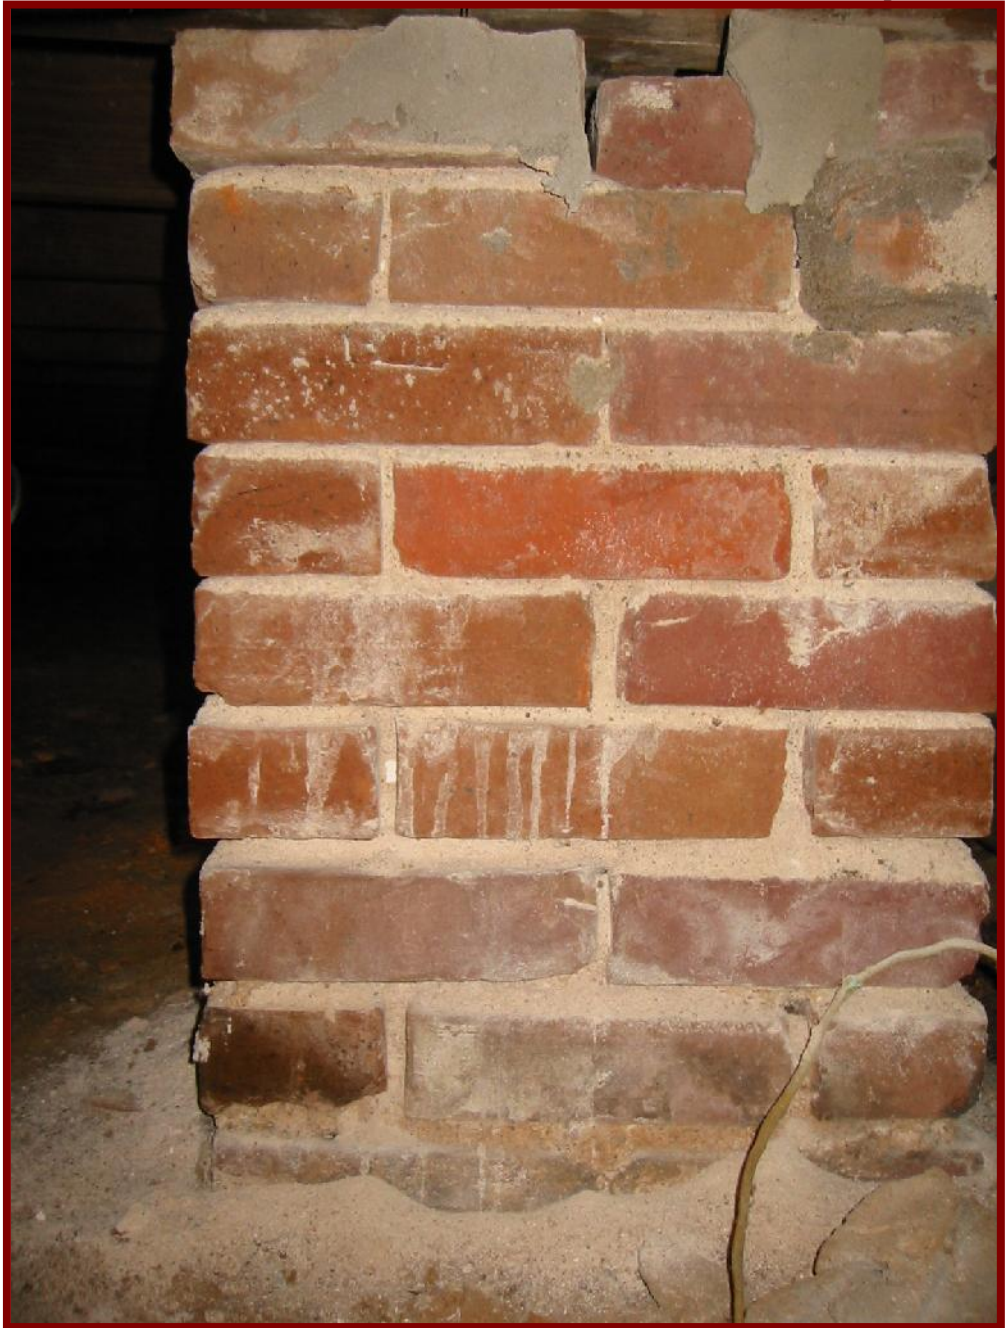
(3) The foundation piers supporting the floor show some typical age related deterioration from a condition known as rising damp. This occurs as the relatively soft, porous old mortar and/ or brick wicks up moisture. Through the years, the mortar and the brick deteriorate and crumble. In the early stages, this isn't a real compromise to the stability of the structure. I consider this to be relatively early in the process, and so I recommend monitoring the piers annually. A competent foundation repair company should be used to make repairs when necessary. Note the deteriorated mortar at the base of the pier in the photo on the next page. The mortar joints in the photos were originally flush with the face of the brick. Note how there is now a sloped concave appearance to the joints due to the loss of mortar.

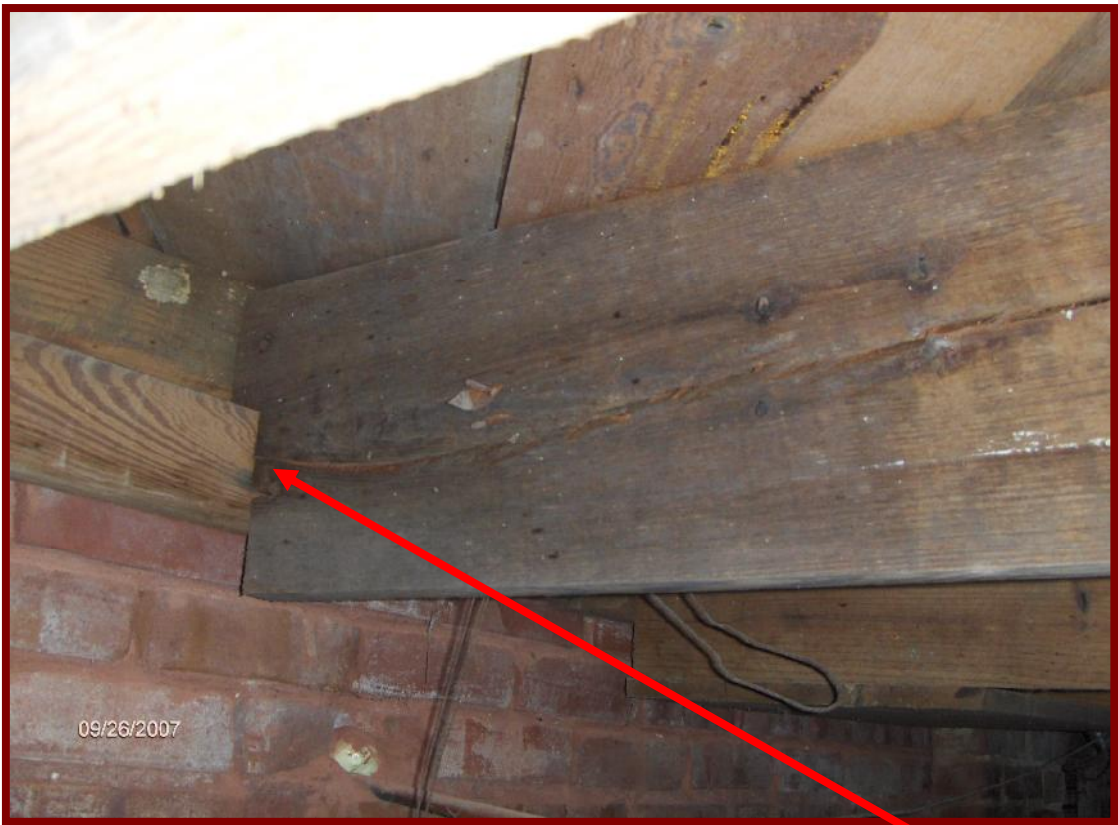
(8) The ends of the floor joists are notched too deeply at their ends and they have split in a few places due to this. Some split joists are a common issue in older homes, but the amount and severity of the split joists seen on this home indicate that repairs by a carpenter are needed now. These contribute to the out-of-level floors in the home. Other than the floor decking itself, there's very little support at the end of this joist.

This split begins here and extends about 3 feet down the joist to the right

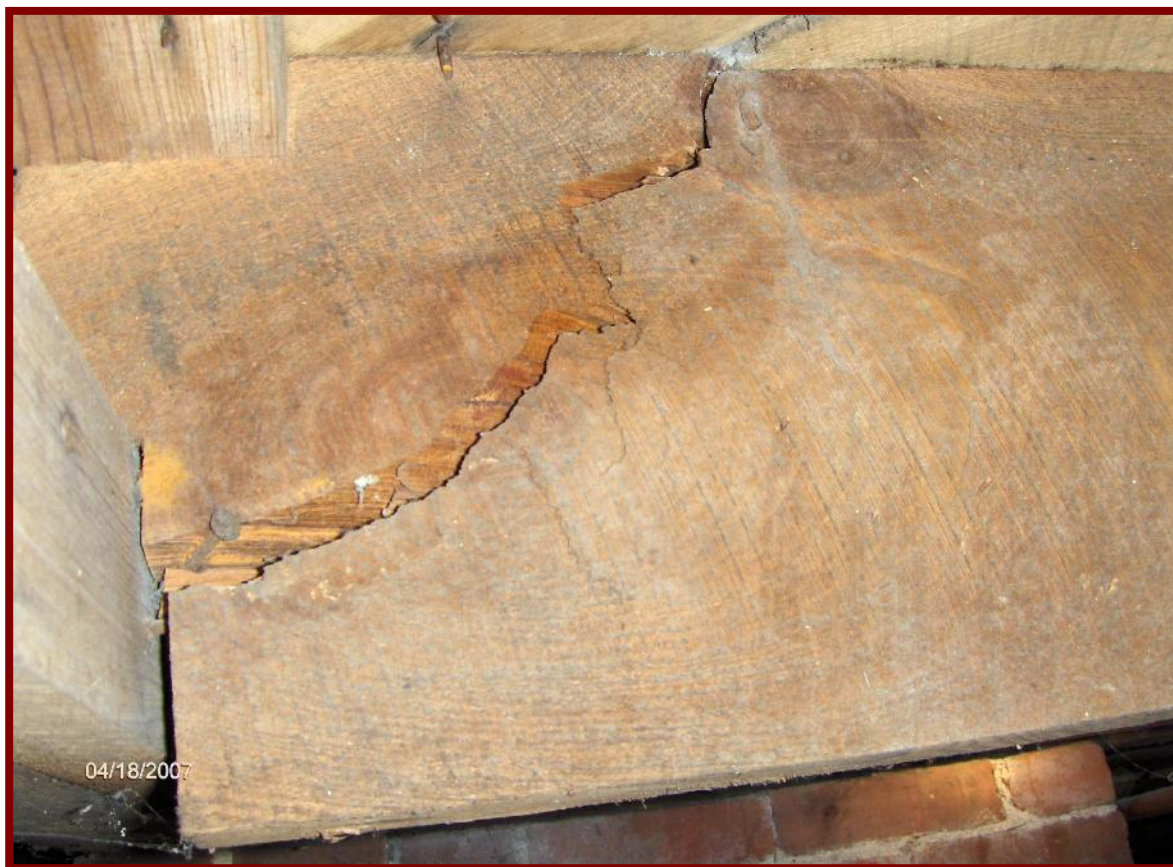
Another problem joist needing repair

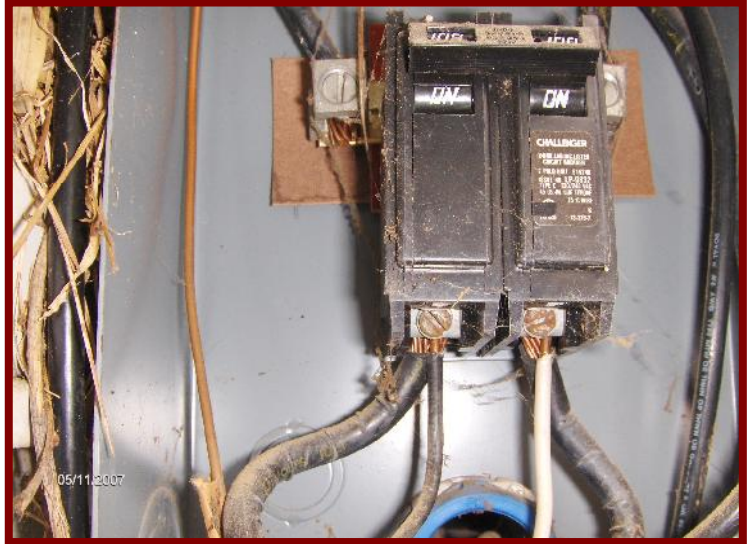
(2) IMPORTANT: This panel has had wires improperly added off of the main breaker. These are significantly undersized for a breaker of this capacity. Due to this and the possibility of loose connections, the potential exists that the wiring can overheat. **This usually indicates amateur work here and repairs should be a priority.**

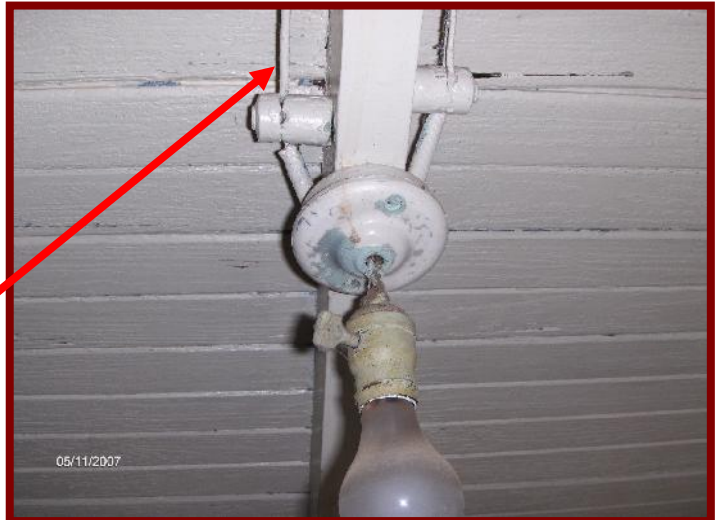
(6) IMPORTANT: Portions of this home are wired with knob-and-tube wiring. K & T wiring is considered obsolete and the cloth and rubber insulation is frequently deteriorated and fragile. Multiple improper connections in more recent years is a common problem too. I strongly recommend that the client have this wiring replaced by a reputable, licensed electrician familiar with this type of wiring. Keep in mind that this is becoming increasingly difficult since the product has not been used since approximately the late 1930's. It is also important to note that an increasing number of insurance companies won't write coverage on homes with this type of wiring.

Note knob and tube wiring

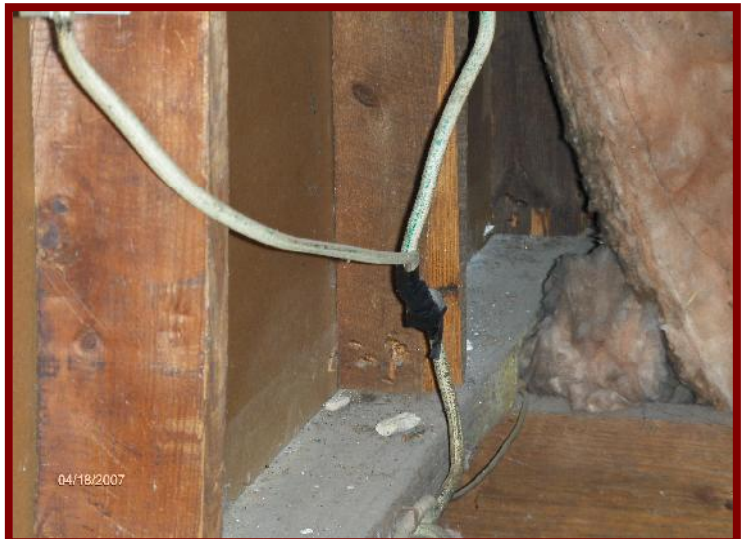
13) I found electrical wires at fixtures or elsewhere in the attic that have been spliced and are not contained in approved junction boxes. This usually indicates that this was done by someone other than an electrician. Recommendation: Have all splices installed inside required junction boxes.

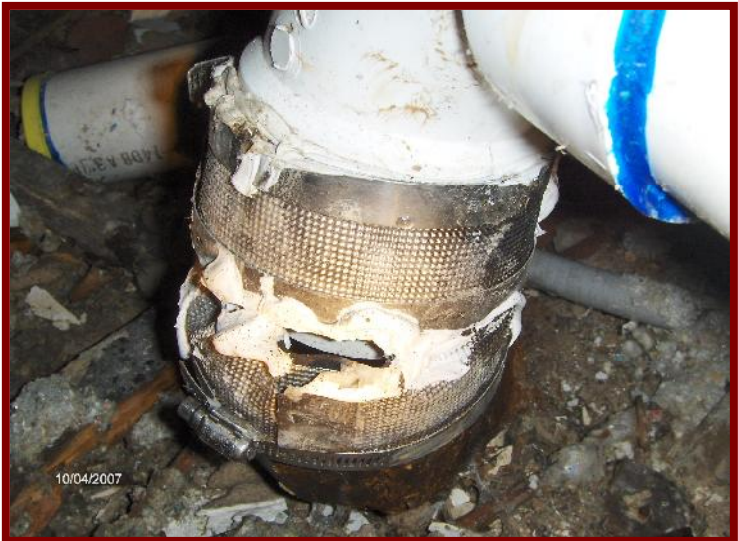
(4) IMPORTANT: Most of the original cast iron drain lines have been replaced with PVC. However, the original underground section is still in place. This has visible cracks and is leaking at the point where the PVC attaches to it. Additionally, the joint is poorly done, relying on a large amount of silicone to try to seal it. This has open holes in it and is leaking. Repairs must be made to avoid additional leakage of waste water into the crawlspace. If this home was occupied, there would be a significant amount of foul water in the crawlspace. Also, based on the deteriorated condition of the visible section of the home's main line, I strongly recommend that further investigation be done. The buried section of the home's line running to the city main may be in need of replacement at this time. I recommend having a sewer cleaning service with a video camera come out and video the interior of the drain.

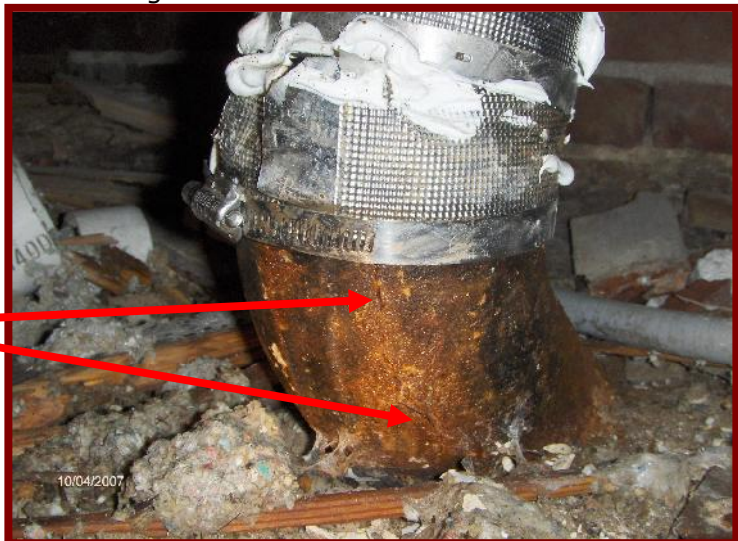
split (hard to see)

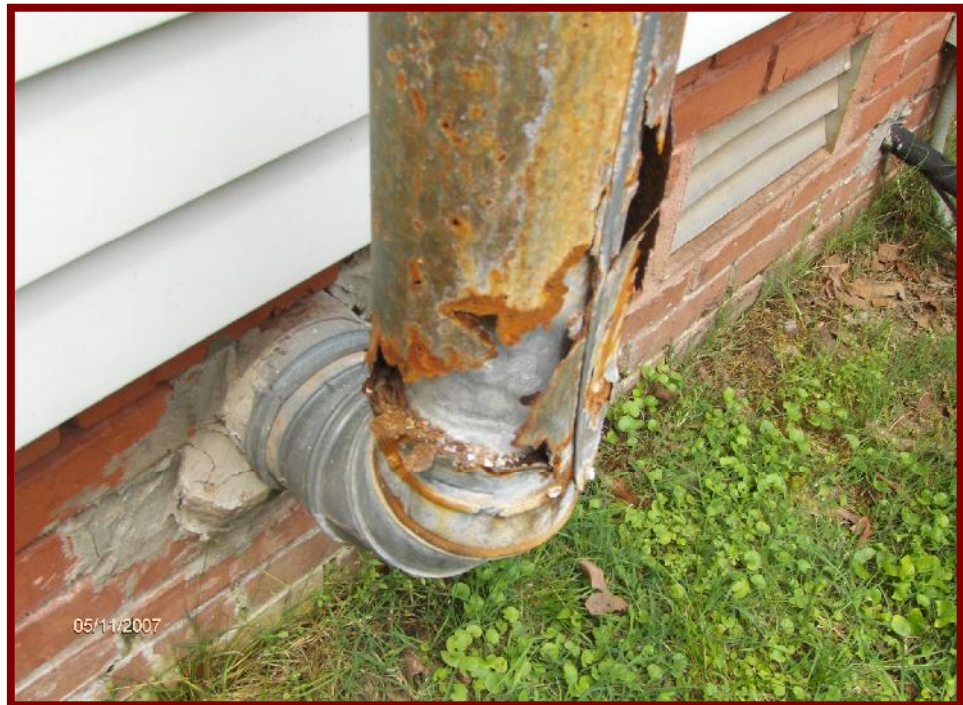
(4) IMPORTANT: The furnace vent is corroded badly, both outside the home and in the crawlspace. Corrosion causes perforations which will allow leakage of combustion waste gases, possibly including carbon monoxide. This should be replaced prior to the next use. Also, due to the long length of the current configuration and the relatively low slope of parts of the run, I advise changing to a power side vent configuration. A reputable heating and air company should be consulted.
